## Anton Art Center - Main Entry Sign

Location                    Mount Clemens, Michigan  
Designer / Architect     Nicolson Associates  
Duration                    Apr 2007 - Jun 2007

Scope - Soheil Mosun Limited was contracted to fabricate and install the main entry sign for the Anton Art Center in Mount Clemens, Michigan, USA.

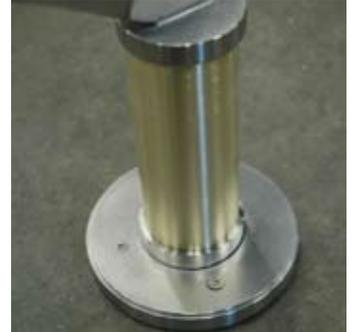
*Brass and steel footings*

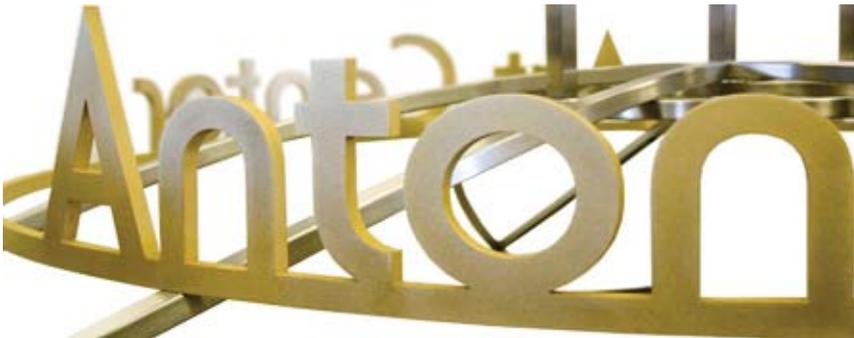
*1/2" Waterjet cut bronze graphics mechanically mounted to a tig welded ring.*

Highlights - This project required the use of Aluminum, Bronze, Stainless Steel and Brass as well as varied finishes for each of these. The Artist's Palette Sculpture is waterjet cut 1/4" stainless steel with painted 1/4" aluminum elements, each mechanically mounted. The main structure is brushed stainless steel 1" square tubing with steel inserts in brushed brass footings. The ring and type graphics are waterjet cut 1/2" bronze with SML's special non-directional finish. The circular band and graphics are mechanically mounted to the chassis which is a brushed stainless steel square tubing structure forming a trois-foil design.

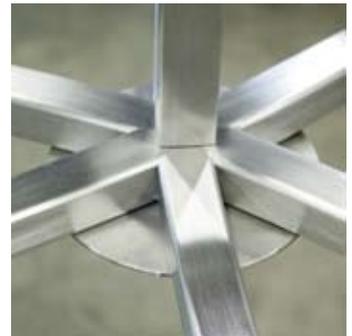
*Ultra fine chassis welding is seamless*

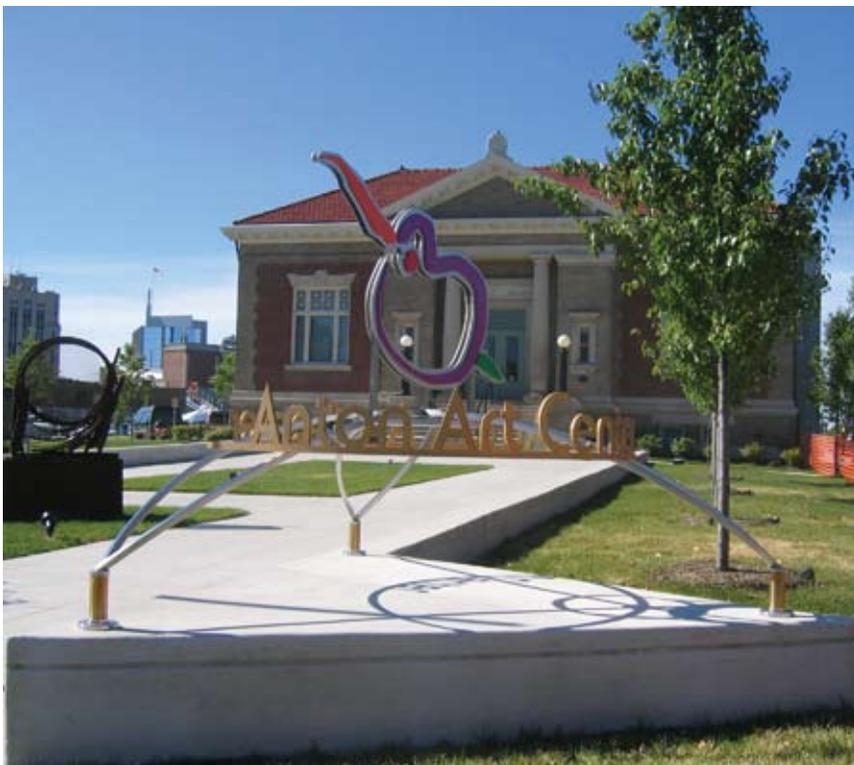
*The finished sign, seen here on site, uses (4) different metals and has (4) different finishes.*

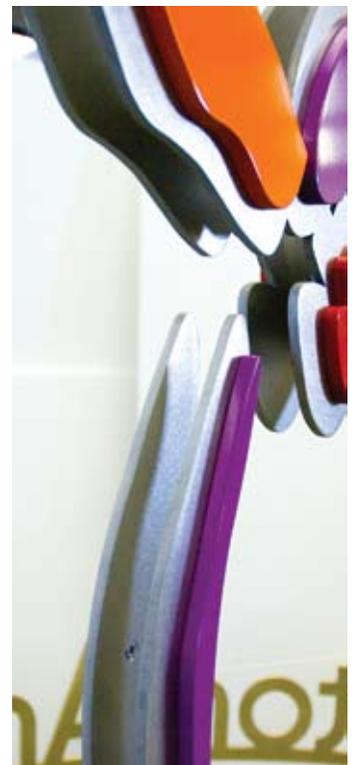
*Painted aluminum mounted to stainless steel*
